RESERVE ANALYSIS REPORT

Barrington Heights HOA

West Linn, OR

Date Prepared: Nov 02, 2020

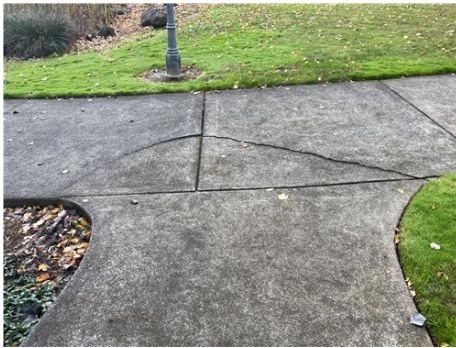
Concrete - Repair Contingency

Component Type:	Reserve Component	GL Code:	
Date in Service:	2017	Cost Center:	
Source:	Inspector	Project Number:	
Owner:			
Effective Age:	4	Current Cost:	\$3,183
Useful Life:	10	Inflation Rate:	
Remaining Life:	6	Starting Reserve Balance:	\$882
Quantity / Units:	1 Total	Annual Fully Funding Requirement:	\$318
Unit Price:	\$3,182.70 / Total	Fully Funded Reserve Balance:	\$1,273
Replacement %:	100.00	Annual Reserve Contribution:	\$264

Contingency for grinding of trip hazards or replacement of broken slabs.

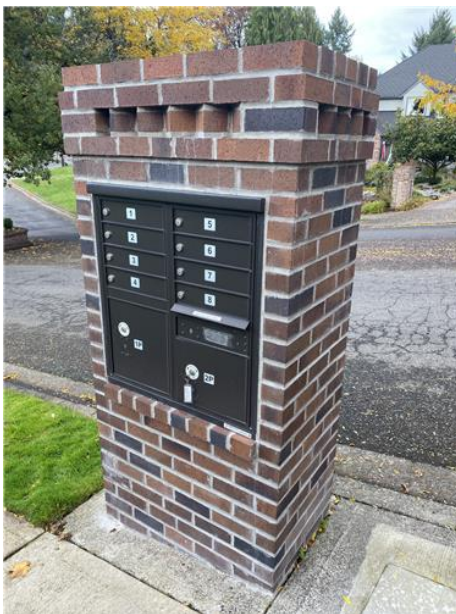
Mailboxes - Clean & Seal

Component Type:	Reserve Component	GL Code:	
Date in Service:	2017	Cost Center:	
Source:	Bid	Project Number:	
Owner:			
Effective Age:	4	Current Cost:	\$7,214
Useful Life:	7	Inflation Rate:	
Remaining Life:	3	Starting Reserve Balance:	\$2,855
Quantity / Units:	34 EA	Annual Fully Funding Requirement:	\$1,031
Unit Price:	\$212.18 / EA	Fully Funded Reserve Balance:	\$4,122
Replacement %:	100.00	Annual Reserve Contribution:	\$854

Clean and seal of mailbox clusters.

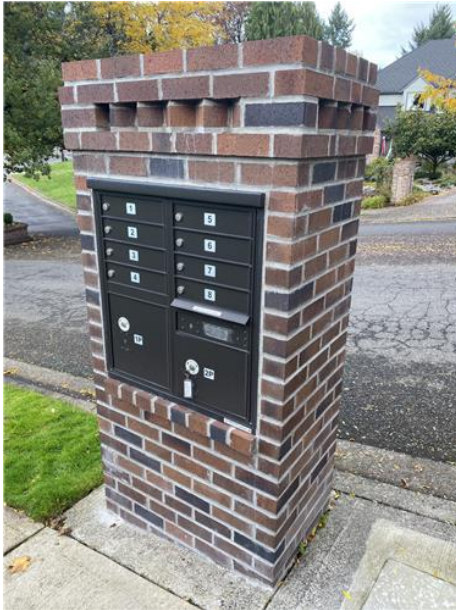
Mailboxes - Renovation - Phase 1

Component Type:	Reserve Component	GL Code:	
Date in Service:	2016	Cost Center:	
Source:	Bid	Project Number:	
Owner:			
Effective Age:	5	Current Cost:	\$24,401
Useful Life:	25	Inflation Rate:	3.00
Remaining Life:	20	Starting Reserve Balance:	\$3,380
Quantity / Units:	4 EA	Annual Fully Funding Requirement:	\$976
Unit Price:	\$6,100.18 / EA	Fully Funded Reserve Balance:	\$4,880
Replacement %:	100.00	Annual Reserve Contribution:	\$809

Replacement of brick mailbox clusters including mailbox insert.

Units replaced in Phase 1: 2040 Wellington drive (2014), 4071 Imperial (2015/16), 4951 Imperial (2015/16), 4037 Imperial (2015/16).

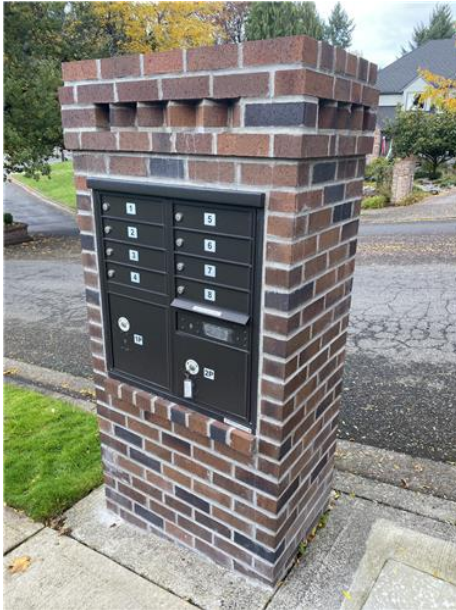
Mailboxes - Renovation - Phase 2

Component Type:	Reserve Component	GL Code:	
Date in Service:	2017	Cost Center:	
Source:	Bid	Project Number:	
Owner:			
Effective Age:	4	Current Cost:	\$24,401
Useful Life:	25	Inflation Rate:	3.00
Remaining Life:	21	Starting Reserve Balance:	\$2,704
Quantity / Units:	4 EA	Annual Fully Funding Requirement:	\$976
Unit Price:	\$6,100.18 / EA	Fully Funded Reserve Balance:	\$3,904
Replacement %:	100.00	Annual Reserve Contribution:	\$809

Replacement of brick mailbox clusters including mailbox insert.

Units replaced in Phase 2: 3832 Fairhaven (2015/16), 2831 Beacon Hill (2015/16), 3931 Edgewood Court (2015/16), 2870 (2017).

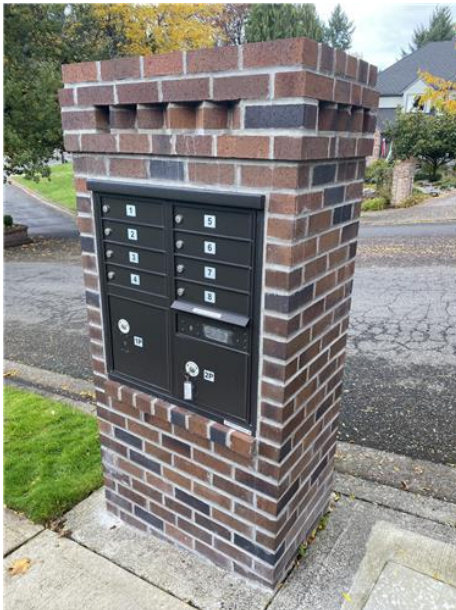
Mailboxes - Renovation - Phase 3

Component Type:	Reserve Component	GL Code:	
Date in Service:	2018	Cost Center:	
Source:	Bid	Project Number:	
Owner:			
Effective Age:	3	Current Cost:	\$24,401
Useful Life:	25	Inflation Rate:	3.00
Remaining Life:	22	Starting Reserve Balance:	\$2,028
Quantity / Units:	4 EA	Annual Fully Funding Requirement:	\$976
Unit Price:	\$6,100.18 / EA	Fully Funded Reserve Balance:	\$2,928
Replacement %:	100.00	Annual Reserve Contribution:	\$809

Replacement of brick mailbox clusters including mailbox insert.

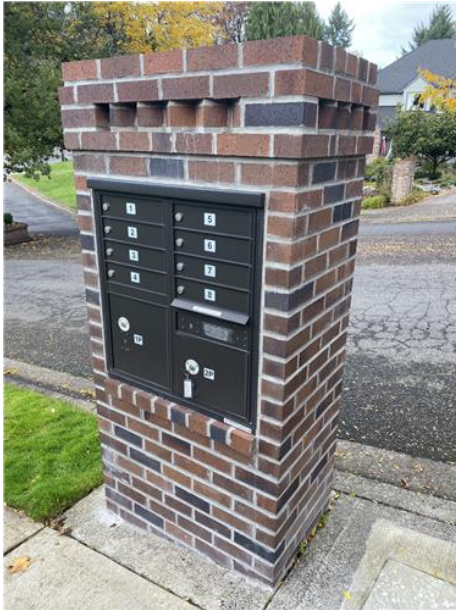
Mailboxes - Renovation - Phase 4

Component Type:	Reserve Component	GL Code:	
Date in Service:	2019	Cost Center:	
Source:	Bid	Project Number:	
Owner:			
Effective Age:	2	Current Cost:	\$24,401
Useful Life:	25	Inflation Rate:	3.00
Remaining Life:	23	Starting Reserve Balance:	\$1,352
Quantity / Units:	4 EA	Annual Fully Funding Requirement:	\$976
Unit Price:	\$6,100.18 / EA	Fully Funded Reserve Balance:	\$1,952
Replacement %:	100.00	Annual Reserve Contribution:	\$809

Replacement of brick mailbox clusters including mailbox insert.

Units replaced in 2014: 2067 Riverknoll Court (2018), 2800 Beacon Hill (2019), 2860 Beacon Hill (2019), 3383 Barrington Drive (2019).

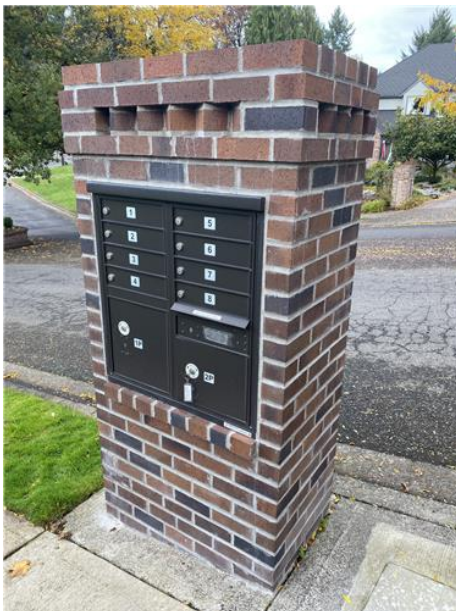
Mailboxes - Renovation - Phase 5

Component Type:	Reserve Component	GL Code:	
Date in Service:	2020	Cost Center:	
Source:	Bid	Project Number:	
Owner:			
Effective Age:	1	Current Cost:	\$24,401
Useful Life:	25	Inflation Rate:	3.00
Remaining Life:	24	Starting Reserve Balance:	\$676
Quantity / Units:	4 EA	Annual Fully Funding Requirement:	\$976
Unit Price:	\$6,100.18 / EA	Fully Funded Reserve Balance:	\$976
Replacement %:	100.00	Annual Reserve Contribution:	\$809

Replacement of brick mailbox clusters including mailbox insert.

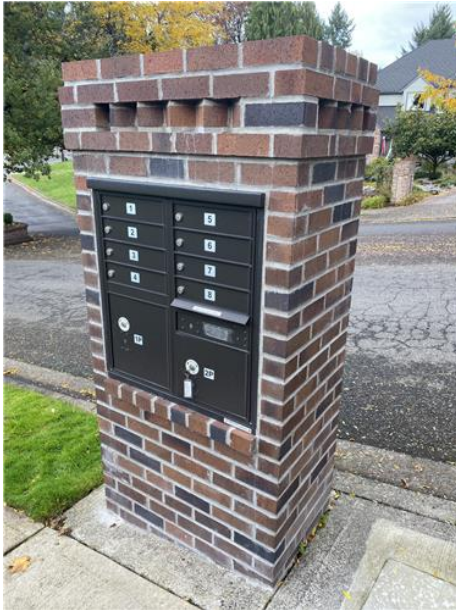
Mailboxes - Renovation - Phase 6

Component Type:	Reserve Component	GL Code:	
Date in Service:	1994	Cost Center:	
Source:	Bid	Project Number:	
Owner:			
Effective Age:	25	Current Cost:	\$18,301
Useful Life:	25	Inflation Rate:	3.00
Remaining Life:	0	Starting Reserve Balance:	\$12,673
Quantity / Units:	3 EA	Annual Fully Funding Requirement:	\$732
Unit Price:	\$6,100.18 / EA	Fully Funded Reserve Balance:	\$18,301
Replacement %:	100.00	Annual Reserve Contribution:	\$606

Replacement of brick mailbox clusters including mailbox insert.

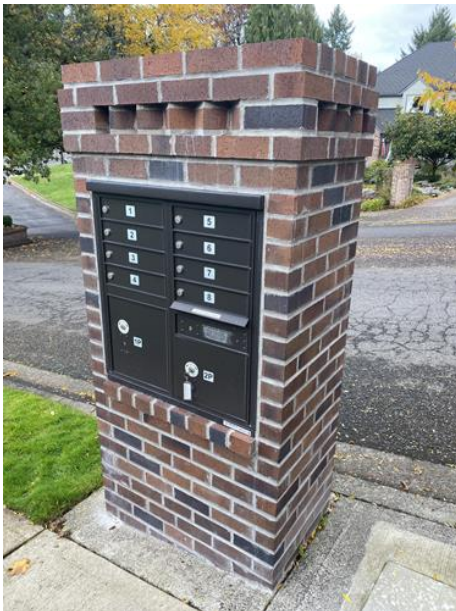
Mailboxes - Renovation - Phase 7

Component Type:	Reserve Component	GL Code:	
Date in Service:	1994	Cost Center:	
Source:	Bid	Project Number:	
Owner:			
Effective Age:	24	Current Cost:	\$24,401
Useful Life:	25	Inflation Rate:	3.00
Remaining Life:	1	Starting Reserve Balance:	\$16,222
Quantity / Units:	4 EA	Annual Fully Funding Requirement:	\$976
Unit Price:	\$6,100.18 / EA	Fully Funded Reserve Balance:	\$23,425
Replacement %:	100.00	Annual Reserve Contribution:	\$809

Replacement of brick mailbox clusters including mailbox insert.

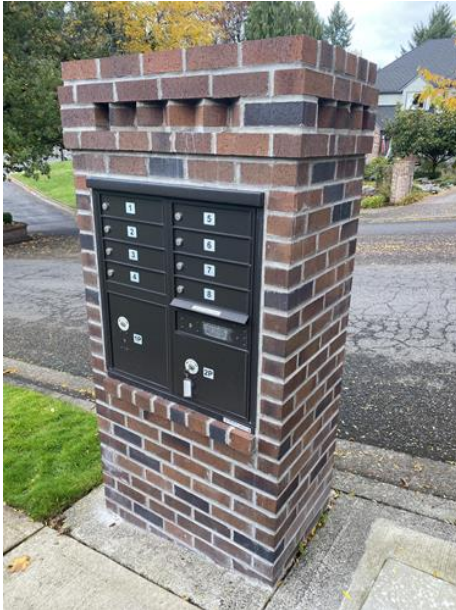
Mailboxes - Renovation - Phase 8

Component Type: Reserve Component
 Date in Service: 1994
 Source: Bid
 Owner:
 Effective Age: 23
 Useful Life: 25
 Remaining Life: 2
 Quantity / Units: 4 EA
 Unit Price: \$6,100.18 / EA
 Replacement %: 100.00

GL Code:
 Cost Center:
 Project Number:
 Current Cost: \$24,401
 Inflation Rate: 3.00
 Starting Reserve Balance: \$15,546
 Annual Fully Funding Requirement: \$976
 Fully Funded Reserve Balance: \$22,449
 Annual Reserve Contribution: \$809

Replacement of brick mailbox clusters including mailbox insert.

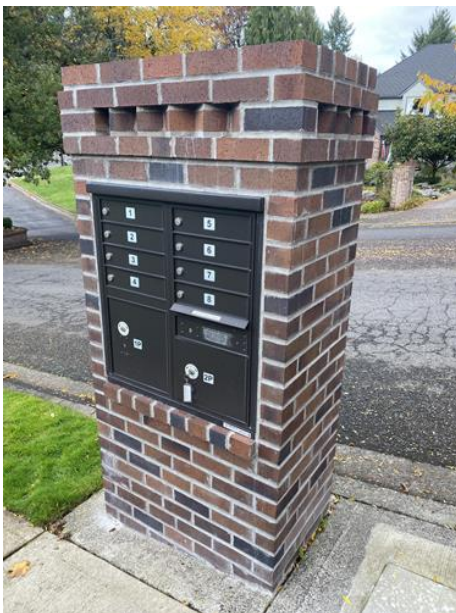
Mailboxes - Renovation - Phase 9

Component Type: Reserve Component
 Date in Service: 1994
 Source: Bid
 Owner:
 Effective Age: 22
 Useful Life: 25
 Remaining Life: 3
 Quantity / Units: 3 EA
 Unit Price: \$6,100.18 / EA
 Replacement %: 100.00

GL Code:
 Cost Center:
 Project Number:
 Current Cost: \$18,301
 Inflation Rate: 3.00
 Starting Reserve Balance: \$11,152
 Annual Fully Funding Requirement: \$732
 Fully Funded Reserve Balance: \$16,104
 Annual Reserve Contribution: \$606

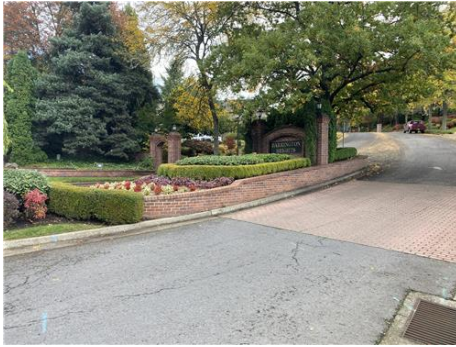
Monuments - Repair, Clean & Seal

Component Type:	Reserve Component	GL Code:	
Date in Service:	2014	Cost Center:	
Source:	Inspector	Project Number:	
Owner:			
Effective Age:	7	Current Cost:	\$15,914
Useful Life:	7	Inflation Rate:	
Remaining Life:	0	Starting Reserve Balance:	\$11,020
Quantity / Units:	1 Total	Annual Fully Funding Requirement:	\$2,273
Unit Price:	\$15,913.50 / Total	Fully Funded Reserve Balance:	\$15,914
Replacement %:	100.00	Annual Reserve Contribution:	\$1,884

Contingency for targeted repair of all brick structures and monuments (excluding mailboxes), followed by a clean and seal of all brick surfaces.

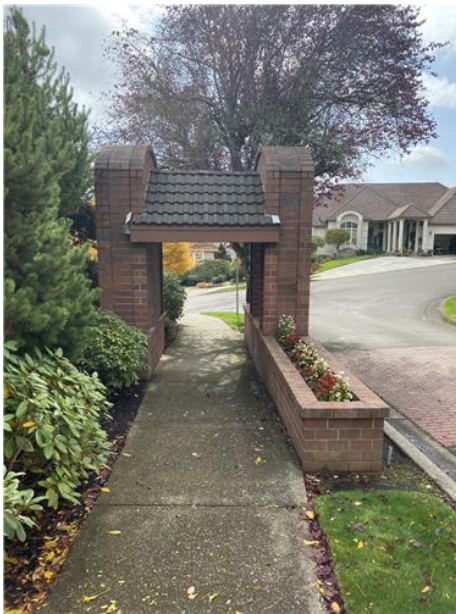
Roof Inspection & Repair - Arches

Component Type:	Reserve Component	GL Code:	
Date in Service:	2016	Cost Center:	
Source:	Inspector	Project Number:	
Owner:			
Effective Age:	5	Current Cost:	\$1,591
Useful Life:	6	Inflation Rate:	0.00
Remaining Life:	1	Starting Reserve Balance:	\$918
Quantity / Units:	1 Total	Annual Fully Funding Requirement:	\$265
Unit Price:	\$1,591.35 / Total	Fully Funded Reserve Balance:	\$1,326
Replacement %:	100.00	Annual Reserve Contribution:	\$220

Contingency to inspect, clean, and repair tile roofs located at brick arches.

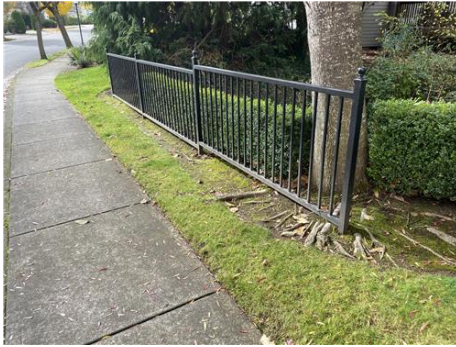
Wrought Iron - Repair

Component Type:	Reserve Component	GL Code:	
Date in Service:	1985	Cost Center:	
Source:	Inspector	Project Number:	
Owner:			
Effective Age:	4	Current Cost:	\$6,709
Useful Life:	30	Inflation Rate:	0.00
Remaining Life:	26	Starting Reserve Balance:	\$619
Quantity / Units:	1 Total	Annual Fully Funding Requirement:	\$224
Unit Price:	\$6,709.13 / Total	Fully Funded Reserve Balance:	\$895
Replacement %:	100.00	Annual Reserve Contribution:	\$185

Repair to all wrought iron gates and fencing.

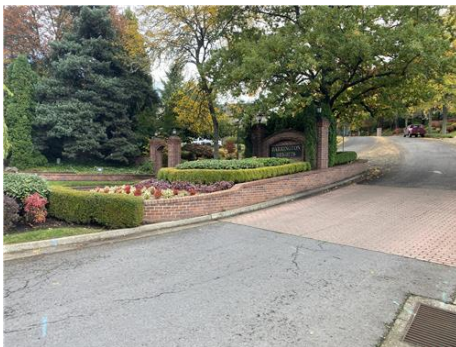
Holiday Tree Lighting

Component Type:	Reserve Component	GL Code:	
Date in Service:	2019	Cost Center:	
Source:	Inspector	Project Number:	
Owner:			
Effective Age:	2	Current Cost:	\$16,338
Useful Life:	5	Inflation Rate:	3.00
Remaining Life:	3	Starting Reserve Balance:	\$4,526
Quantity / Units:	1 Total	Annual Fully Funding Requirement:	\$3,268
Unit Price:	\$16,337.86 / Total	Fully Funded Reserve Balance:	\$6,535
Replacement %:	100.00	Annual Reserve Contribution:	\$2,707

Cost to replace lighting in big trees.

Pricing based on 2018 cost from Innovative Nightscapes.

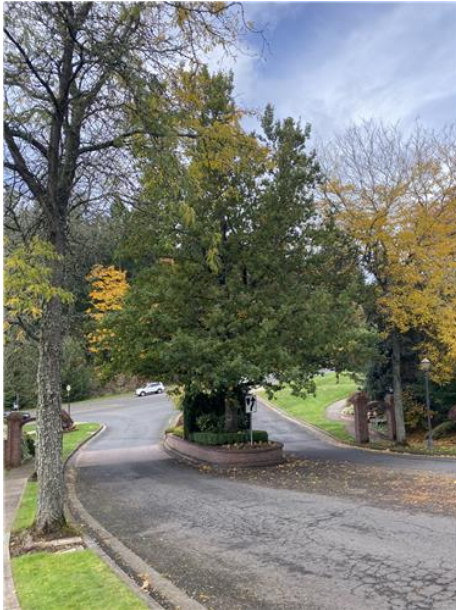
Tree Maintenance

Component Type:	Reserve Component	GL Code:	
Date in Service:	2015	Cost Center:	
Source:	Inspector	Project Number:	
Owner:			
Effective Age:	1	Current Cost:	\$7,957
Useful Life:	5	Inflation Rate:	
Remaining Life:	4	Starting Reserve Balance:	\$1,102
Quantity / Units:	1 Total	Annual Fully Funding Requirement:	\$1,591
Unit Price:	\$7,956.75 / Total	Fully Funded Reserve Balance:	\$1,591
Replacement %:	100.00	Annual Reserve Contribution:	\$1,318

Contingency for pruning or removal and replacement of commonly maintained trees.

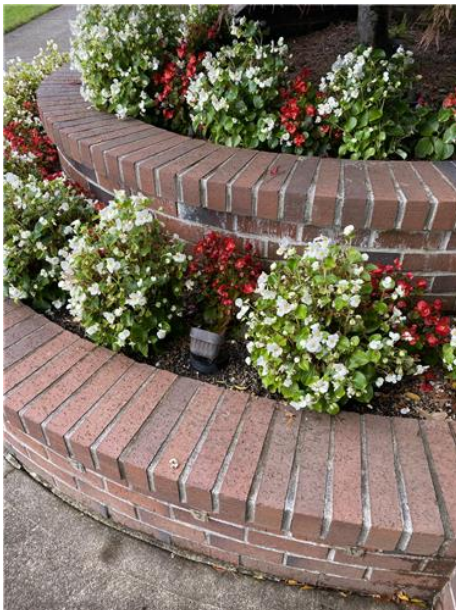
Low Voltage

Component Type:	Reserve Component	GL Code:	
Date in Service:	2016	Cost Center:	
Source:	Inspector	Project Number:	
Owner:			
Effective Age:	5	Current Cost:	\$17,505
Useful Life:	10	Inflation Rate:	0.00
Remaining Life:	5	Starting Reserve Balance:	\$6,061
Quantity / Units:	1 Total	Annual Fully Funding Requirement:	\$1,750
Unit Price:	\$17,504.85 / Total	Fully Funded Reserve Balance:	\$8,752
Replacement %:	100.00	Annual Reserve Contribution:	\$1,450

Replacement of low voltage lighting systems and fixtures.

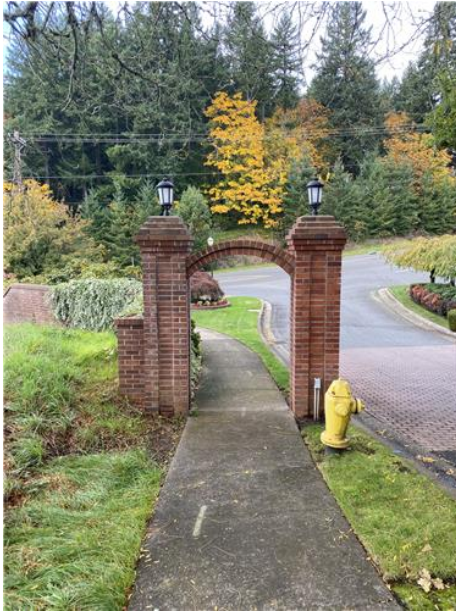
Monument Fixtures - Replacement Contingency

Component Type:	Reserve Component	GL Code:	
Date in Service:	2016	Cost Center:	
Source:	Previous Study	Project Number:	
Owner:			
Effective Age:	6	Current Cost:	\$5,305
Useful Life:	30	Inflation Rate:	0.00
Remaining Life:	24	Starting Reserve Balance:	\$735
Quantity / Units:	20 EA	Annual Fully Funding Requirement:	\$177
Unit Price:	\$530.45 / EA	Fully Funded Reserve Balance:	\$1,061
Replacement %:	50.00	Annual Reserve Contribution:	\$146

Contingency for replacement of monument lighting fixtures.

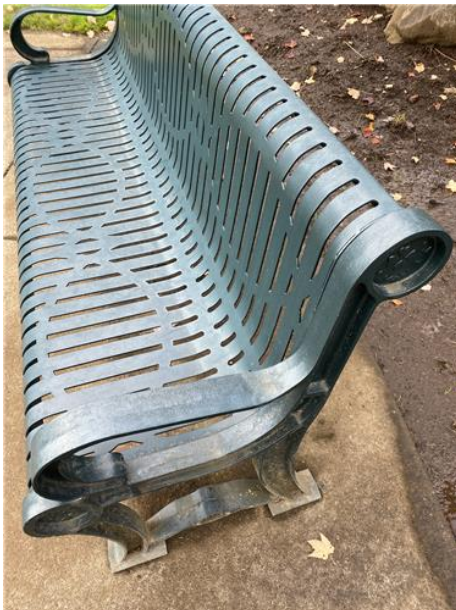
Bench Painting

Component Type:	Reserve Component	GL Code:	
Date in Service:	2013	Cost Center:	
Source:	Inspector	Project Number:	
Owner:			
Effective Age:	8	Current Cost:	\$583
Useful Life:	8	Inflation Rate:	
Remaining Life:	0	Starting Reserve Balance:	\$404
Quantity / Units:	1 Total	Annual Fully Funding Requirement:	\$73
Unit Price:	\$583.50 / Total	Fully Funded Reserve Balance:	\$583
Replacement %:	100.00	Annual Reserve Contribution:	\$60

Cost to prep and repaint bench located in greenspace at Salamo entrance.

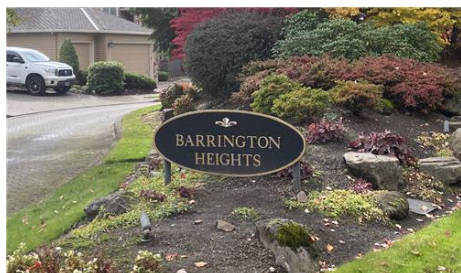
Signage - Repair/Repaint/Replace

Component Type:	Reserve Component	GL Code:	
Date in Service:	2017	Cost Center:	
Source:	Inspector	Project Number:	
Owner:			
Effective Age:	4	Current Cost:	\$5,570
Useful Life:	10	Inflation Rate:	
Remaining Life:	6	Starting Reserve Balance:	\$1,543
Quantity / Units:	1 Total	Annual Fully Funding Requirement:	\$557
Unit Price:	\$5,569.73 / Total	Fully Funded Reserve Balance:	\$2,228
Replacement %:	100.00	Annual Reserve Contribution:	\$461

Contingency for inspection and repair or replacement of entry signage to Barrington Heights.
